Road Safety Audit
Stage 1
for
PROPOSED HOUSING DEVELOPMENT
AT
RATHMULLAN, CO MEATH

Date: June 2019

Reference: RSM/MOB/121118/RATHMULLAN RSA1

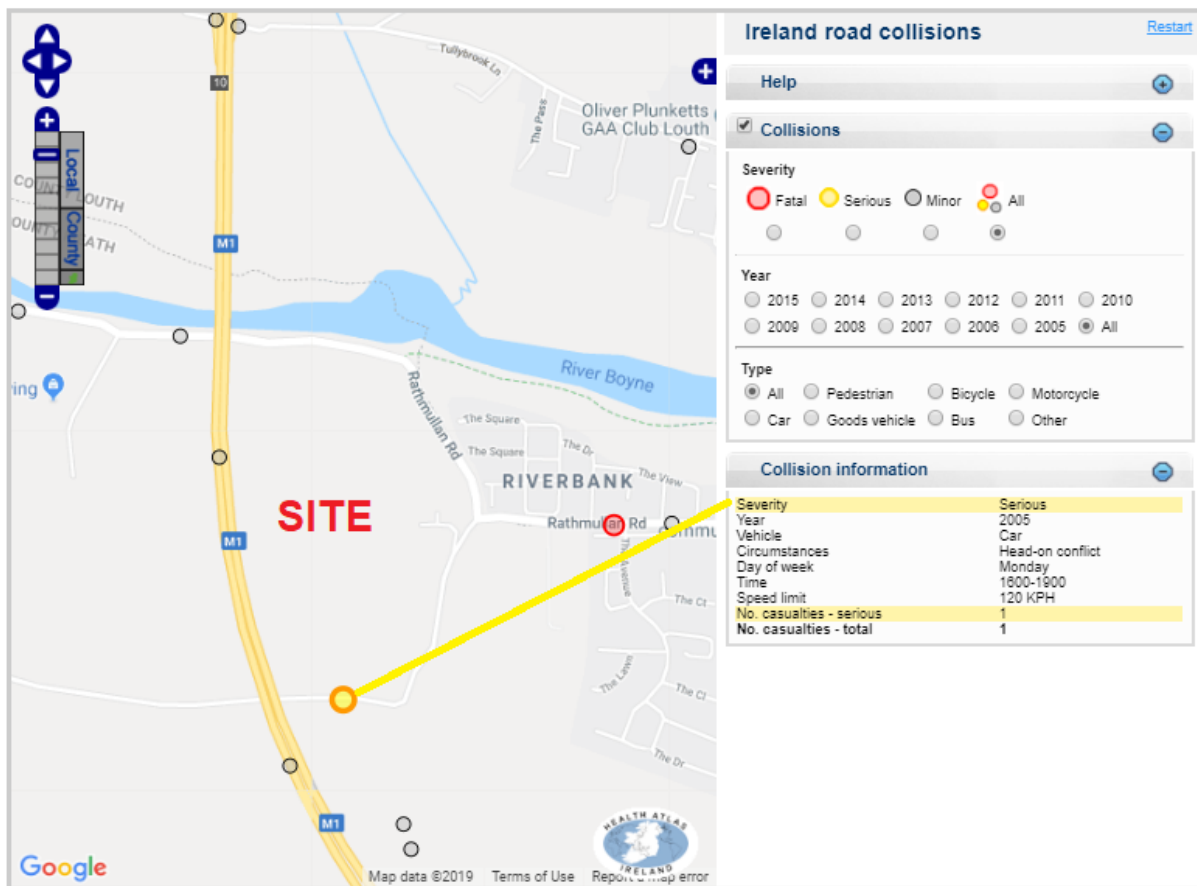
Figure 3

2.1.3 No information was provided on any existing collision statistics in the vicinity of the site. A review of the Road Safety Authority (RSA) online collision database indicates that there was one serious collision recorded on the existing road network immediately adjacent to the proposed development site between 2005 and 2015 inclusive, at the location shown in figure 3. The collision involved a head on conflict, and it was noted on site that the carriageway cross section is relatively narrow at this location, which is likely to preclude safe two way movement at all times, and which should be considered in improvement of the road network surrounding the site.

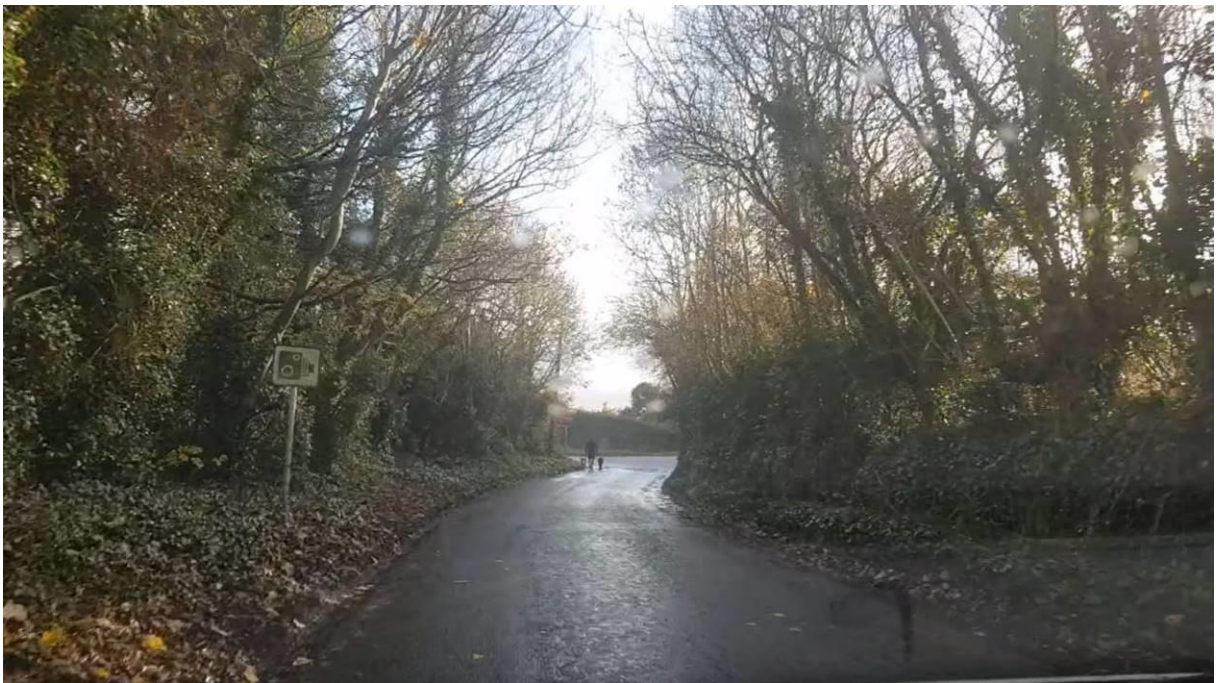
Figure 4

An existing speed camera sign, shown in figure 4, was also noted on Rathmullan Road on the southbound approach to the existing priority controlled junction which will be reconfigured to form the signalised crossroads at the main site access point. The criteria for installation of a speed camera include installation at locations which have higher than average collision rates for recorded volumes (per million vehicle kilometres) on similar road classifications, including collisions which result in high casualty severity. It should be noted that the RSA database is not a comprehensive record of collisions, and should be reviewed in conjunction with the Local Authority / Gardaí records for the site, to include an investigation into installation criteria for the speed camera.

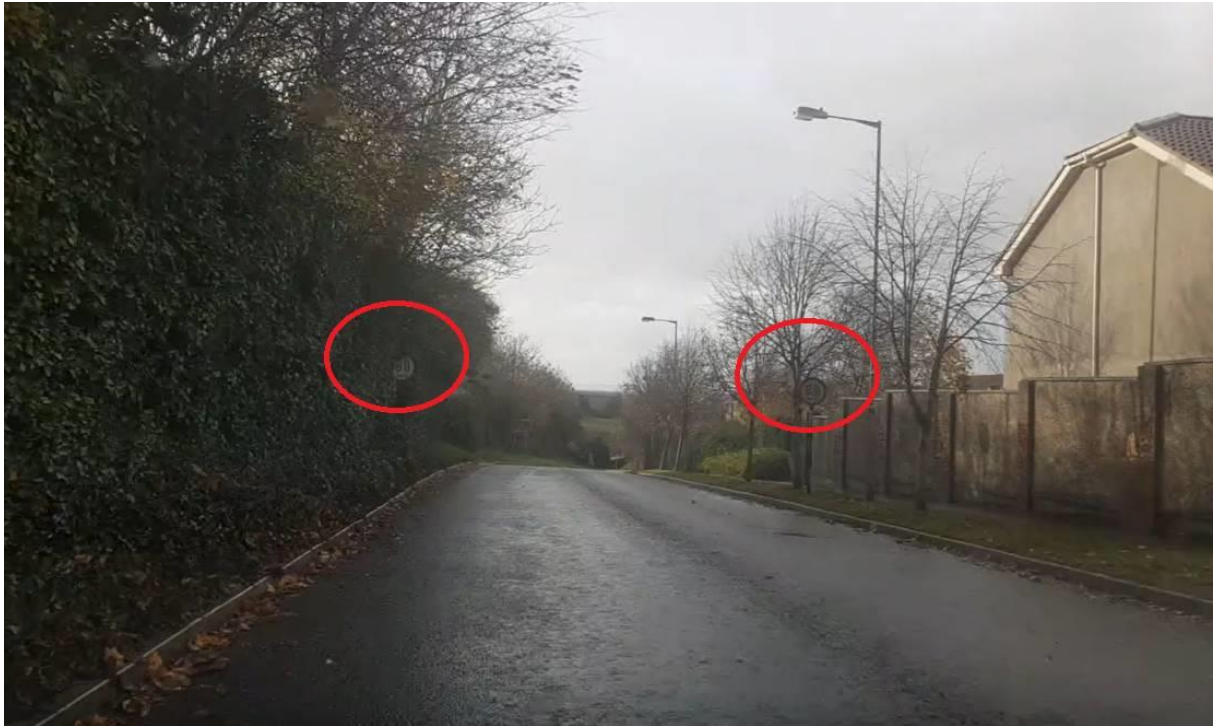
Figure 5

There was no 85th percentile speed survey data provided for the existing link adjacent to the site, however the site is located within the rural speed limit zone of 80 km/hr, with the entry to the urban speed limit zone of 50 km/hr currently located approximately 150m east of the site, and the proposed signalised crossroads. The current speed limit changeover location is shown in figure 5, and there is no 60 km/hr speed limit transition zone at present between the urban and the rural classifications. A rural speed limit of 80 km/hr would be inappropriate for the site and for the

roads surrounding the site, based on the scale and urban nature of this proposed residential development. Inappropriate speeds will increase the risk of collision for all road users, particularly VRUs travelling to and from the site.

A review of the location and suitability of the current speed limit on the network surrounding the site is advisable on all approaches to the site at detailed design stage, to include an extension of the 50 km/hr speed limit zone and the inclusion of a 60 km/hr transition zone and entry treatment to the urban area at a suitable location on approaches to the site.

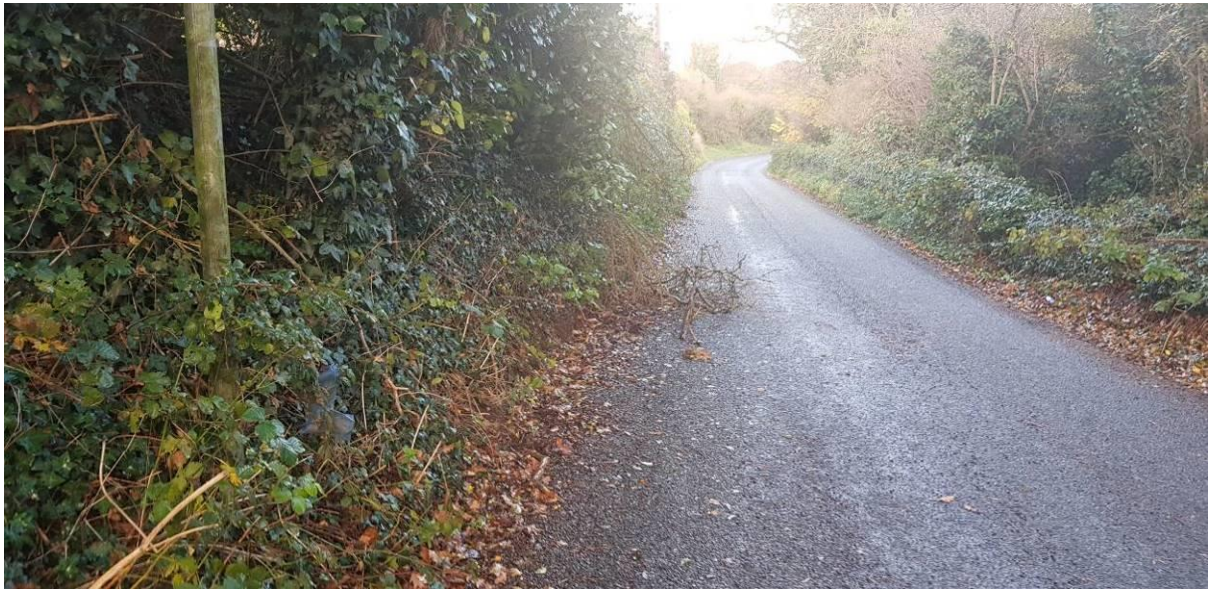
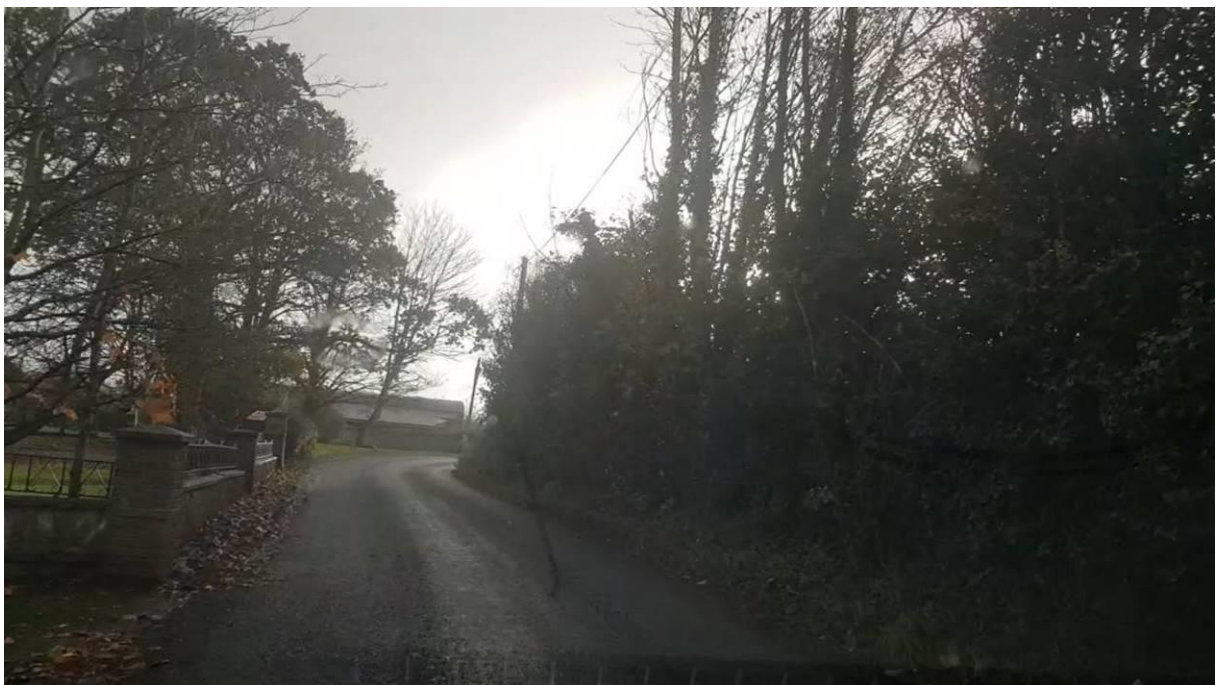
There were no details provided for proposed landscaping/boundaries within the site and along the site boundary. Retaining walls have been shown indicatively at two locations, however no levels have been provided for roads/footways at either side and the preliminary design earthworks or proposals for regrading of existing embankments elsewhere. Dense hedging and relatively steep overgrown embankments are currently located along a significant proportion of the site boundary, as shown in figures 6 and 7, with some overhanging trees and vegetation leading to the potential for slippery conditions on the adjacent carriageway, and hedging also leading to reduced sightlines at other locations, and the preliminary design layout does not show proposals for removal of this vegetation.

Inappropriately located landscaping or boundaries exceeding 1.05m in height along the site frontage or along any of the links throughout the site, particularly in the vicinity of junctions or curved sections of road, may compromise visibility splays and sightlines, and may compromise intervisibility between pedestrians or motorists, or to and from vehicles reversing from

Landscaping proposals should be clarified at detailed design stage, with all trees and landscaping to be located away from positions which could increase the risk of conflict or have a negative impact on intervisibility at VRU desire lines, or where shedding leaves may cause slip/trip hazards. Proposed or existing landscaping and boundary treatments throughout and surrounding the site, should be located outside visibility splays or provided at a height less than 1.05m above ground level. Internal boundaries, walls and landscaping should also be offset a safe distance from the edge of carriageway, and forward visibility and stopping sight distance at all junctions and along Rathmullan Road adjacent to the site and all internal links should be clear and unobstructed in accordance with traffic speeds.

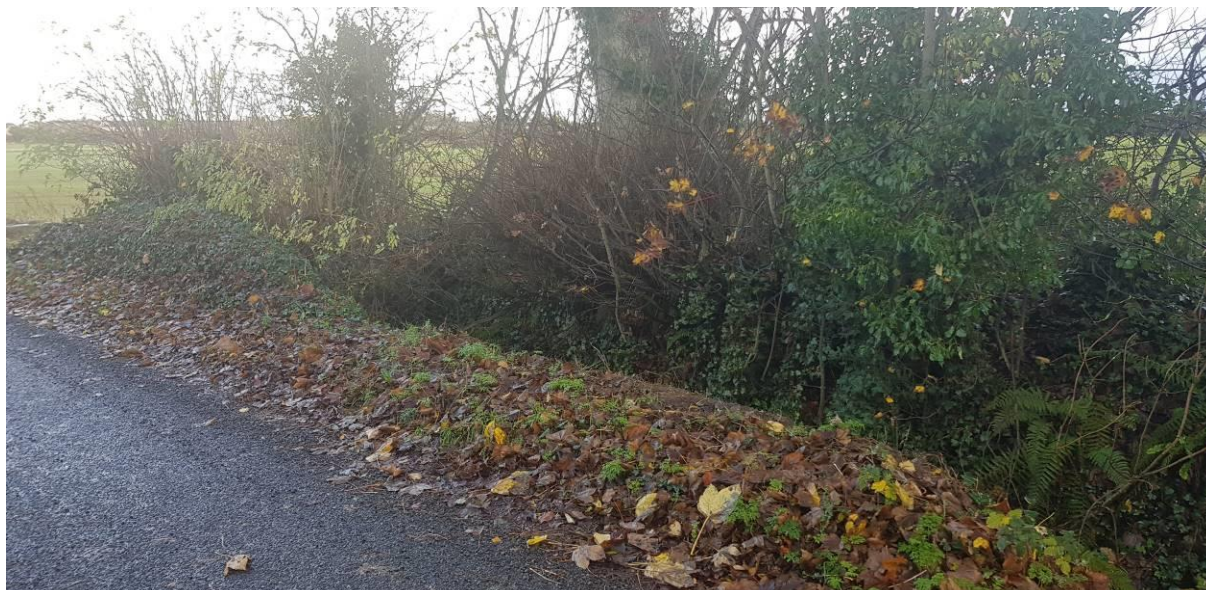
Figure 8

The preliminary design layout includes provision for gullies along the realigned Rathmullan Road and along all links within the site, however gullies have been provided within footways and on pedestrian desire lines throughout the site, where they will present a hazard to pedestrians. Elsewhere within the site, there were no gullies provided adjacent to ramps at the end of relatively steep gradients on links, where ponding may arise. Externally on the existing road network, it was noted that there are also a number of exposed ditches immediately adjacent to the existing carriageway on Rathmullan Road, as shown in figure 8, and no details have been provided on treatment of these hazards on the new alignment.

The new layout will need to be adequately drained to minimise the risk of ponding and build-up of surface water, which can increase risks for all road users and increase the risk of skidding and loss of control.

The detailed design drawings should include drainage details along the site frontage, including treatment of existing exposed water hazards and ditches within the clearzone of the new road alignment surrounding the site. Gullies should be provided at a suitable location to each side of the ramps/tables to address surface water runoff. All new gullies throughout the site and on approaches to the site should be flush with the surrounding pavement, and placed in a location which is outside the desire line for pedestrians and two-wheeled vehicles.

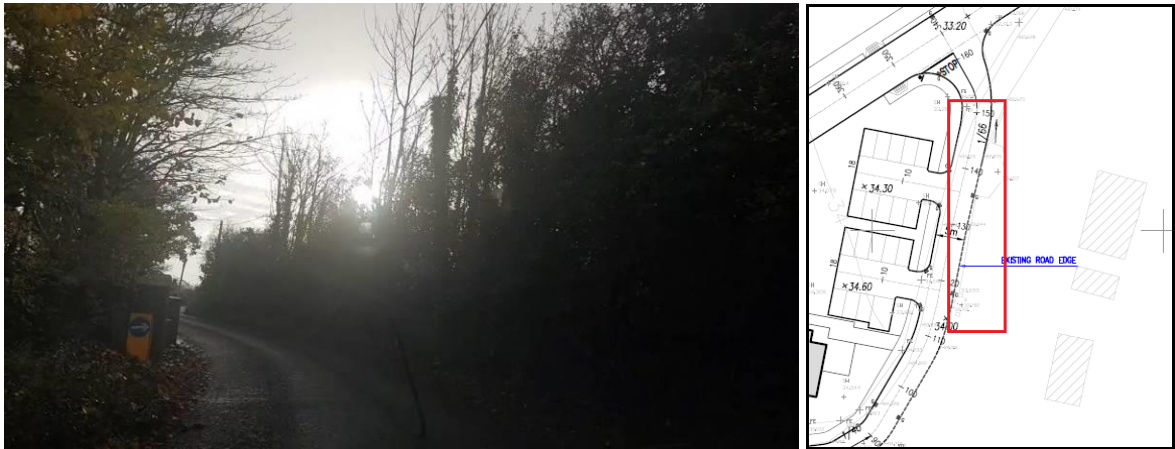
Figures 9 & 10

There were no details provided on site clearance proposals to determine treatment of all existing features within and surrounding the site which will be displaced by the works, including services and overhead power lines. A number of other features will be displaced by the site proposals, including existing gates and utility poles and the final locations of any of these features to be retained are not clear from the plans supplied. It was noted that existing solid boundary walls are located immediately adjacent to the running lane, as shown in figure 9 (approx. chainage 120-150m highlighted in figure 10), and there is no provision for a suitable offset on the proposed layout at this location. Inappropriately located features adjacent to the Rathmullan Rd carriageway may present a hazard within the clearzone or a strike hazard to passing and turning vehicles.

Detailed design should also include site clearance to show treatment of all existing features on the site which will be effected by the proposed works, including buildings, mature trees/vegetation, gates, services, walls and utilities. All potential hazards should be located outside the clearzone where possible, and at a sufficient offset from carriageway edges.

2.1.9 Problem - Site Clearance and potential hazards in clearzone	Yes	Site clearance proposals will be clarified as part of the detailed design process. The proposed treatment of the existing overhead lines is shown on drawing No. 18-014-P052 and will be subject to agreement with ESB.

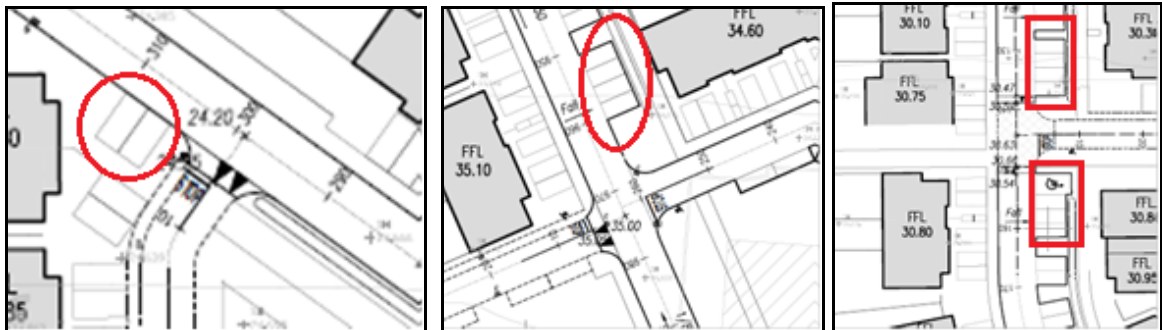
Figures 11-13: Perpendicular Parking near Junctions

It was noted that a number of internal parking spaces are configured as perpendicular spaces, and are located in close proximity to junctions where vehicles will be queuing and turning, and where vehicles parked are likely to present obstructions in visibility splays, with examples of where this may occur shown in figures 11-13. Obstructions in visibility splays increases the risk of pulling out and right angled collisions. Vehicles parked adjacent to pedestrian desire lines can also restrict intervisibility between approaching motorists and pedestrians waiting to cross, increasing the risk of pedestrian/VRU conflict.

Total parking demands for the site should be assessed, with on street parking to be restricted adjacent to all junction visibility splays and at locations where intervisibility between road users could be compromised, and with visibility splays to be clear and unobstructed at all times in accordance with traffic speeds. Parking configuration to be parallel where possible, with perpendicular parking and the potential for reversing manoeuvres to be avoided adjacent to junctions and likely pedestrian desire lines to cross the carriageway. Any parking demands on street should be closely monitored to ensure vehicles do not obstruct the safe passageway of pedestrians or restrict the turning movements and visibility of other vehicles.

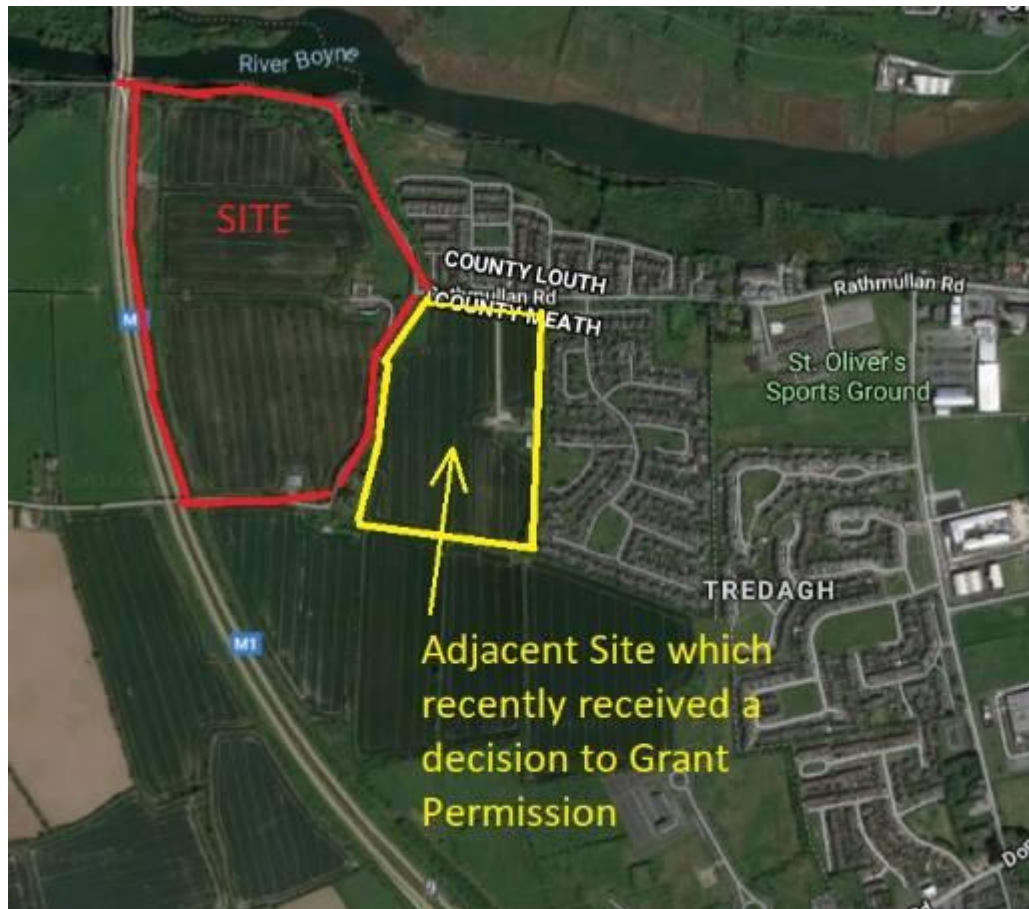
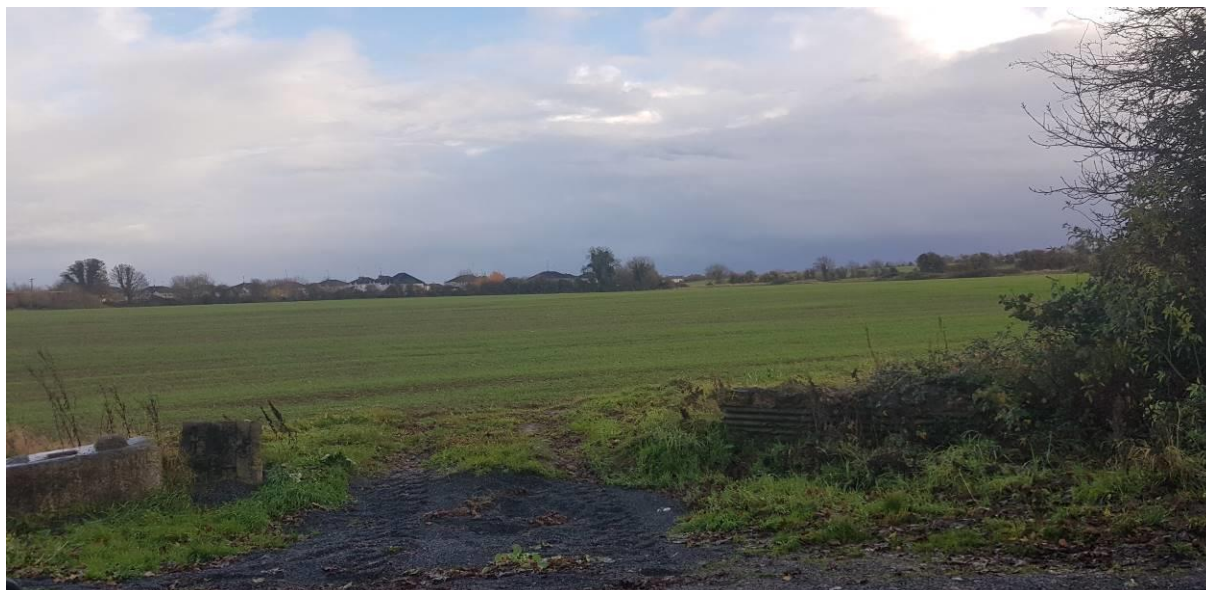
It was noted that an adjacent greenfield site, indicatively shown in figure 14 with one of the current access points into the site shown in figure 15, which will be located in relatively close proximity to proposed access junctions into the subject site. It is understood that this site has recently received a decision to grant permission for development. The Audit Team considered that the cumulative impact of traffic generated by both sites combined will have a significant impact on the capacity of Rathmullan Road and the safe operation of all proposed access

junctions, and both sites are also likely to generate significant desire lines for VRU access to and from the Drogheda direction. There are no current VRU facilities on Rathmullan Rd surrounding the site, and the preliminary design layout does not appear to include provision for cyclists within the cross section of Rathmullan Road, with provision for pedestrians along one side of the carriageway only, and limited provision for crossing opportunities.

Traffic volumes, compositions and turning movement proportions should be examined, and the Designer should demonstrate that the geometry of each of the proposed access junctions will be sufficient to accommodate all anticipated volumes and vehicle sizes and that the cross section on the major road can accommodate all anticipated vehicle movements, including the cumulative impact from all committed developments and modes.

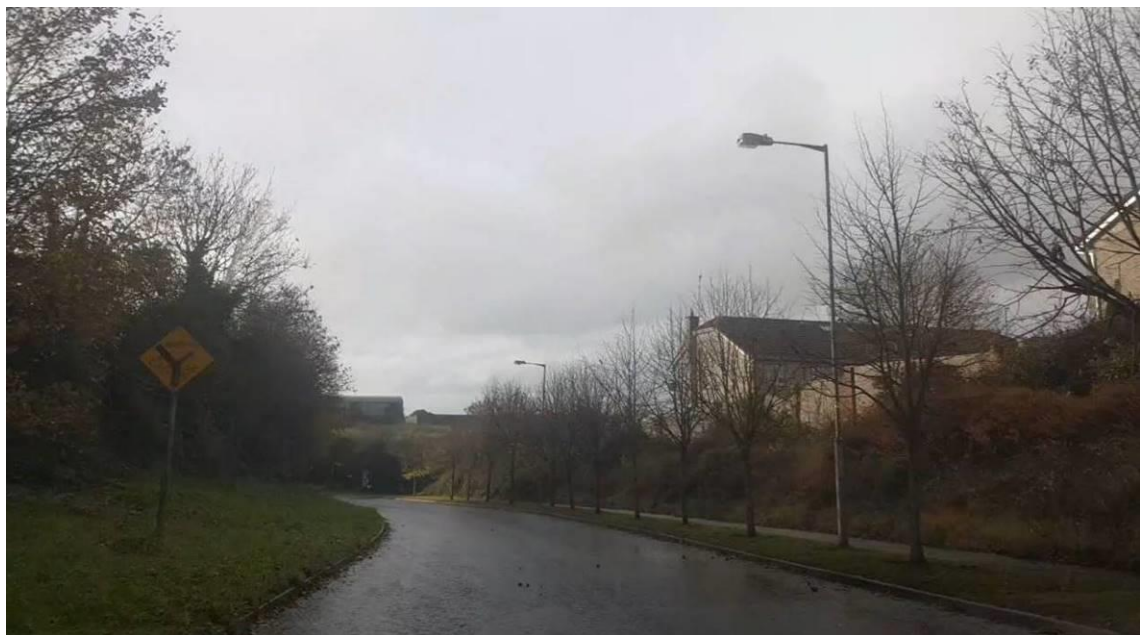
Figure 16 shows the existing horizontal alignment on the westbound approach to the signalised crossroads, where clear forward visibility towards the nearside primary signal head aspect is likely to be restricted. This approach is also located on a significant downhill gradient, which may effect stopping sight distance, particularly in wet and icy conditions. Figure 17 shows the southbound approach to the proposed signals, where vegetation and embankment on the offside of the right hand bend are compromising sightlines at present towards the junction, and where the proposed radius will be tighter than the existing, which may lead to reduced visibility towards the signals and towards queing vehicles. Figures 18 and 19 show the horizontal alignment further north adjacent to the Boyne River, where the cross section is very narrow and where vehicles cannot pass safely without stopping. Carriageway condition is also poor in this locality. Existing safety issues in the locality may increase risks to road users accessing the development site.

The Designer should demonstrate that unobstructed visibility splays can be achieved at all proposed priority controlled access junctions into the site, and that the junction intervisibility zone will not be obstructed at the signalised crossroads. Suitable forward visibility and stopping sight distance should be provided along the Rathmullan Road, including towards the rear of any anticipated queues at any of the proposed junctions and access points. Likely vehicle speeds on the link should be considered in determination of the visibility and minimum cross section requirements, with sufficient traffic calming and speed control measures to be considered as necessary, if DMURS reduced visibility splays are to be considered, with more formal entry treatment into the urban zone as necessary, as recommended previously.

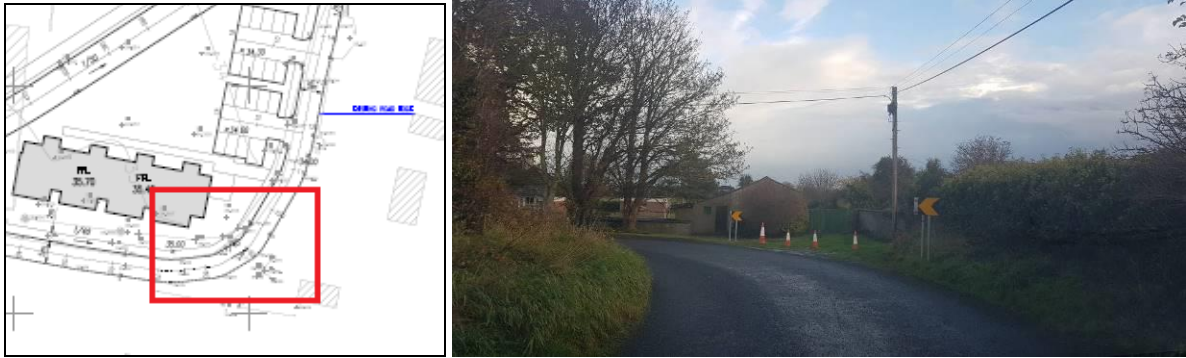
Figures 20 & 21

Figures 20 and 21 show the relatively tight radius and limited SSD on the existing link between chainages 310m and 420m approximately, where a significant portion of the existing link will be retained to provide access to existing properties and new parking/development, which are shown in figure 20. The preliminary design does not include for alignment or SSD improvements at this location.

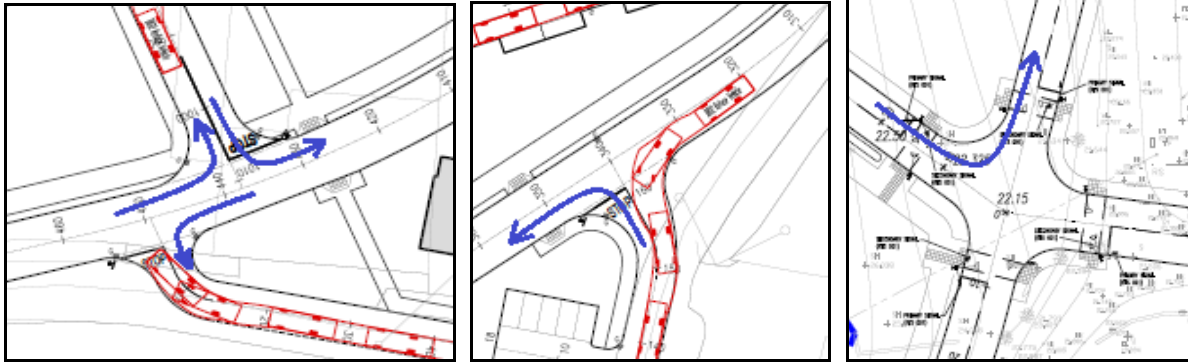
Figures 22-24

The swept path analysis provided demonstrated that the proposed access geometry for the priority controlled access points to the site will generally accommodate the turning manoeuvres of the design vehicle (refuse vehicle), and which will require relatively infrequent access, although encroachment into the path of oncoming vehicles was noted. The analysis shown in figure 19 shows that vehicles waiting to turn out of this junction will significantly restrict movement for vehicles turning in. There were a number of movements to and from the site and at the signalised crossroads which have not been included in the analysis provided, and which may present difficulties for some vehicles. These locations have been highlighted in figures 22-24.

The proposed geometry at each access point should safely accommodate the anticipated turning manoeuvres of all vehicle sizes with adequate margins of safety, on all permissible movements.

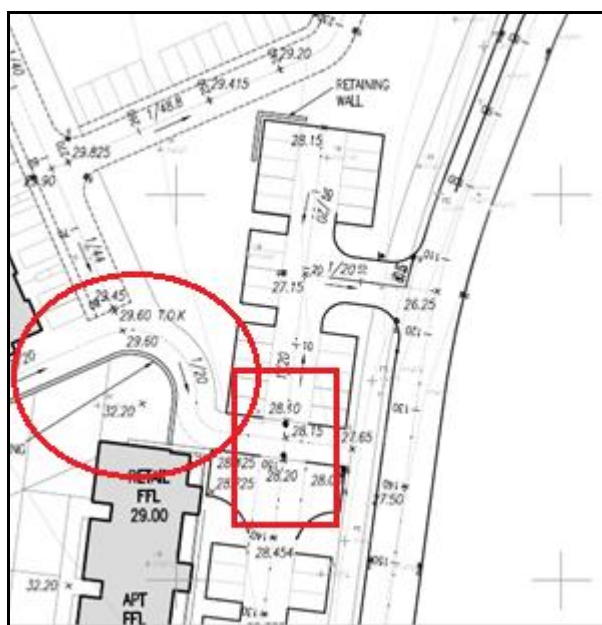
There are significant level differences within the site, leading to gradients of 5-8% at some locations, including a 5% gradient on the eastbound approach to the stoplines at the signalised crossroads, which will present difficulties for some road users. Figure 25 shows a location where there is a 1/20 gradient in 3 directions with no level dwell area at the access point/intersection with Rathmullan Road. The general details in this area are unclear in respect of permissible movements, accessibility, alignment to the south and clearance to the proposed retaining wall. Inappropriate levels and relatively steep gradients on links within the site are likely to present difficulties for wheelchair access or for access for those with buggies or for elderly pedestrians. There were no cross sections provided for links throughout the site to determine any potential issues in terms of trip hazards or kerb heights, which may also present difficulties for mobility and visually impaired pedestrians.

The gradients and vertical design should be reviewed throughout the site, and a longitudinal profile produced at detailed design stage to demonstrate that all gradients throughout the site will be safe for use by all road users, and to minimise the risk of larger vehicles overturning on bends or encroaching into the path of oncoming vehicles, creating a head on collision risk. The proposals for access and clearance adjacent to the retaining wall shown in figure 25

should also be clarified. A recommended 600mm clearance should be provided to all solid boundaries within the site from the edge of carriageway, with a minimum 450mm clearance to be provided to all other boundaries, street furniture and signage.

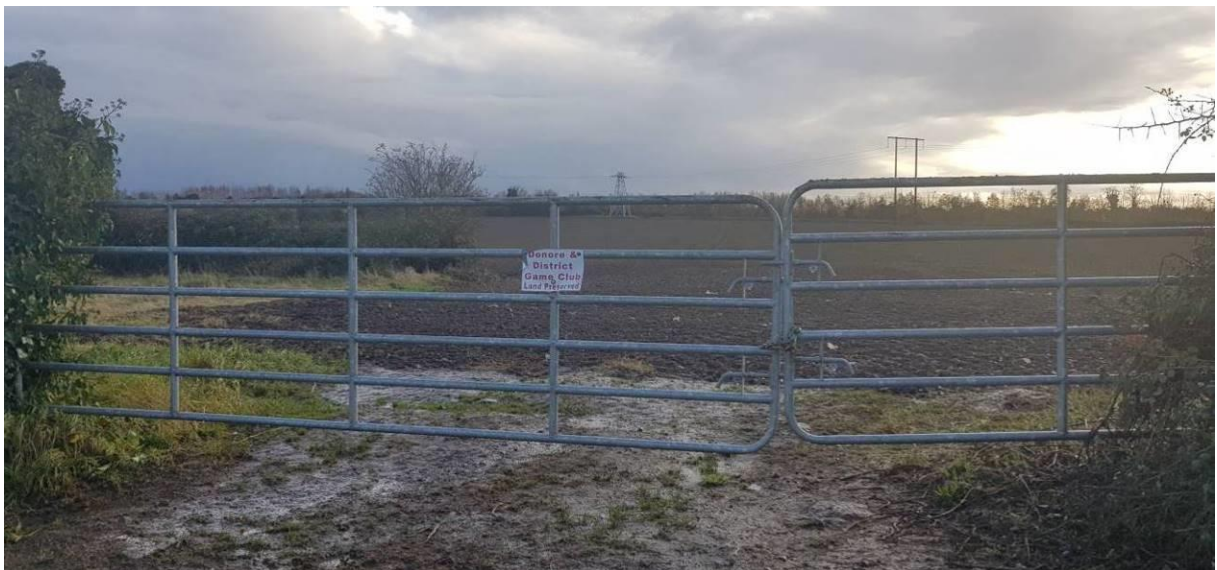
Figure 26

A number of existing access points may be effected by the proposed works, which have not been shown on the preliminary design layout, with an example shown in figure 26. Figure 27 shows two proposed access junctions to the north and south of Rathmullan Road where there is minimal stagger offset between the junctions, which increases risks to vehicles turning to and from these locations. There is no stagger offset provided at a number of internal junctions within the site, which have been configured as crossroads junctions. Crossroads junctions typically have higher collision rates than suitably staggered junctions due to the higher risk of crossover and right angled collisions, particularly where there may be obstructions in visibility splays to the left or right.

The design should include provision for suitable stagger offsets at junctions and access points to minimise the risks arising from multiple potential points of conflict in close proximity. Detailed design should show all existing access points to be retained along the Rathmullan Road, and the designer should demonstrate that safe access to and from these points will not be effected by the proposed works.

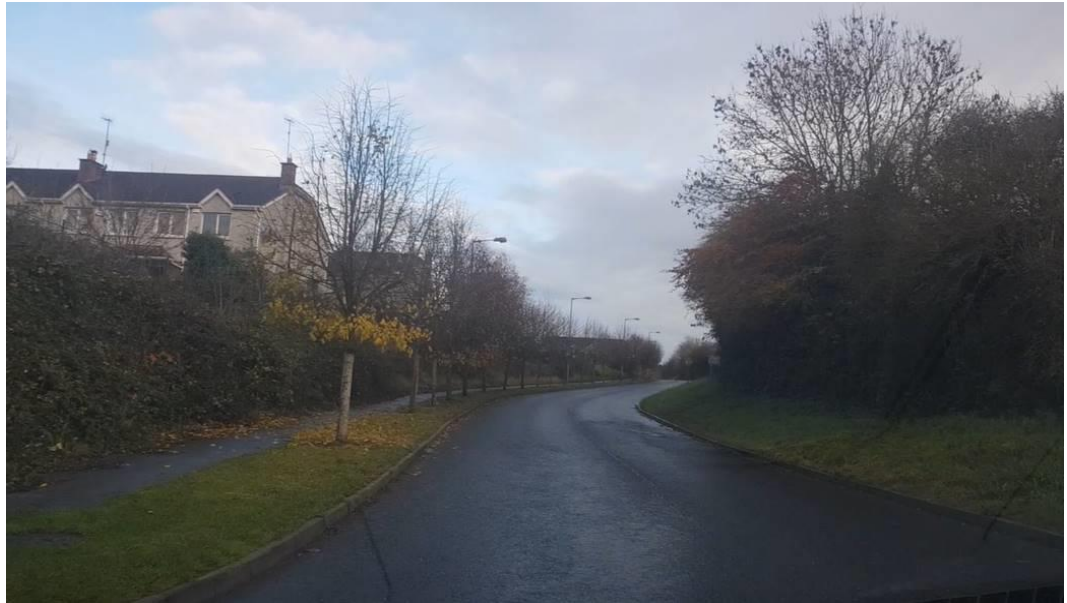
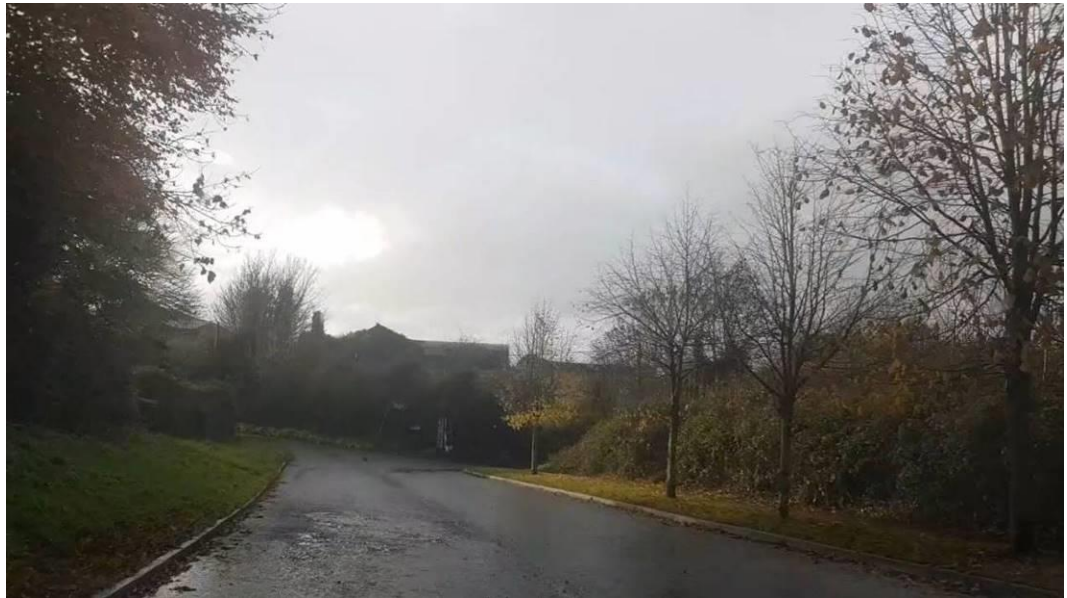
- There were a number of pedestrians observed walking within the carriageway of Rathmullan Road at the time of the site visit, where there is no current provision for and footways. The preliminary design layout shows a disconnected and discontinuous footway network along Rathmullan Road which is unlikely to fully cater for all existing and future demands.
- There is no footway continuity at the following locations:
 - on the southern side of the carriageway on the eastern arm of the signalised crossroads
 - on the eastern side of the southern arm of the signalised crossroads
 - On the western side of the northern arm of the crossroads
 - Figure 28 shows proposals for a footway on the northern side of the eastern arm of the crossroads, which appears to be tying into the existing verge, with a row of trees at this location, as shown in figures 29 and 30.

Pedestrian activity, desire lines and demands should be considered both within the site and on tie-in points on the routes used to access the site, with detailed design layout to be finalised taking into account all issues raised above. Details of all kerb heights to be clarified at detailed design stage, with a maximum kerb upstand of 6mm to be installed on all desire lines to cross the carriageway across the path of moving vehicles, and dropped kerbs ideally flush with the adjacent road surface. Footways should be clear and unobstructed at all times, with a minimum continuous width of 2m to be provided in an urban zone, and a minimum crossing width of 2.4m,

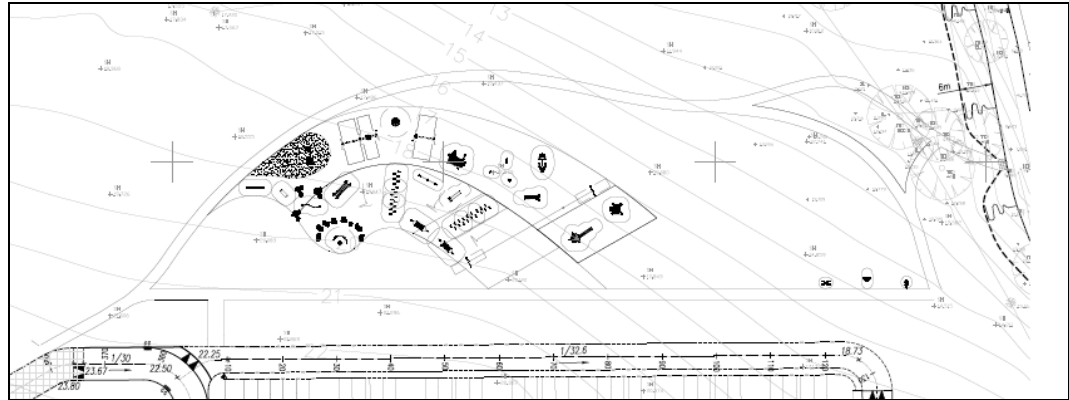
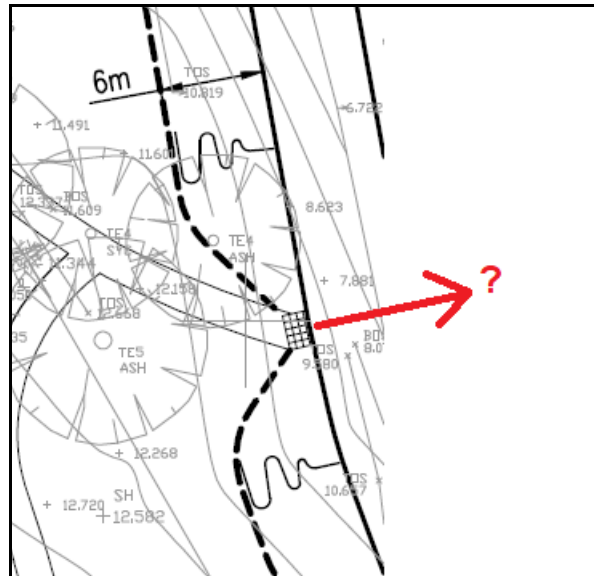
- The continuity of the footway shown in figures 32 and 33 is unclear from the plans supplied, and there appears to be provision for pedestrians to cross the carriageway to access the river walkway, which is shown in figures 34-36. Visibility to and from pedestrians waiting to cross at the potential crossing point shown in figure 33 is likely to be compromised by horizontal curvature, embankments and dense vegetation. Visibility to and from all formal and informal crossing points throughout the scheme should be clear and unobstructed in accordance with traffic speeds, with pedestrians to be visible from a point 2m back from the road edge. Safe connectivity to the river walkway should be provided on both side of the carriageway.

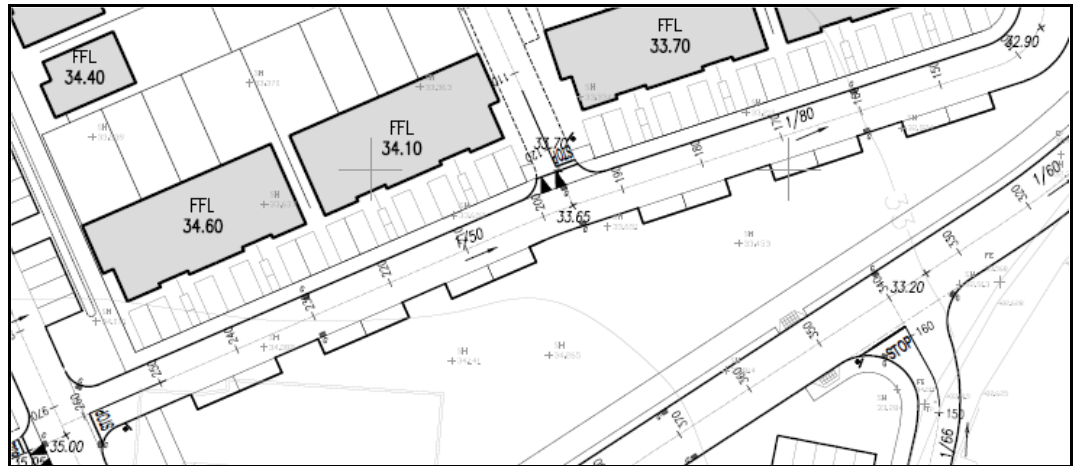
Figure 37

- Within the site it was noted that there is no consistent provision for footways to the rear of all parking spaces. At locations where no footways have been provided, e.g. figure 37, pedestrians will need to walk within carriageway in an uncontrolled manner to access the footpath network, where the risk of conflict with passing vehicles will be higher.

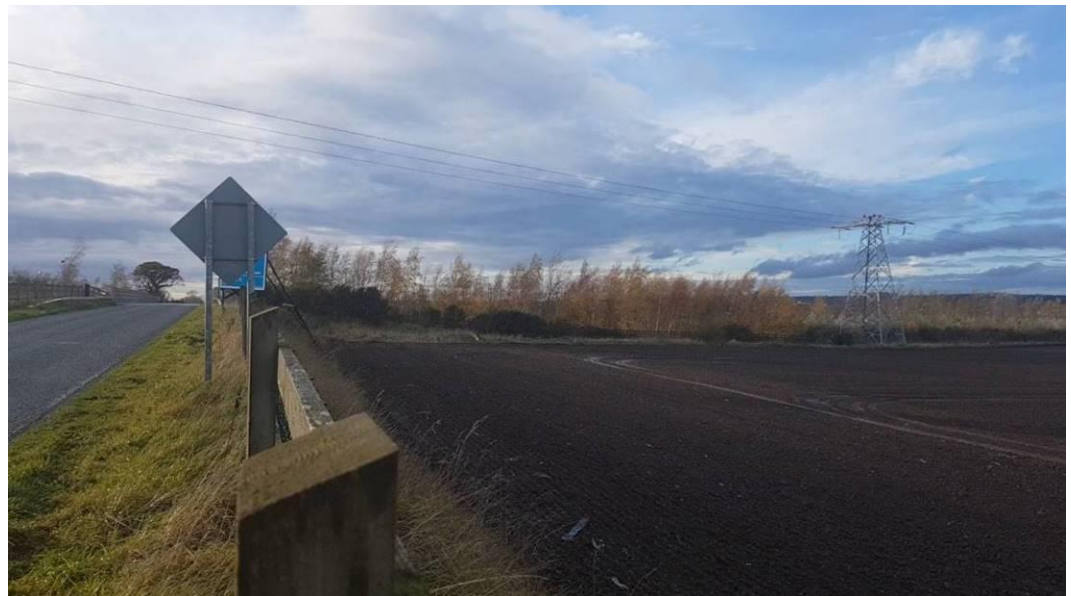
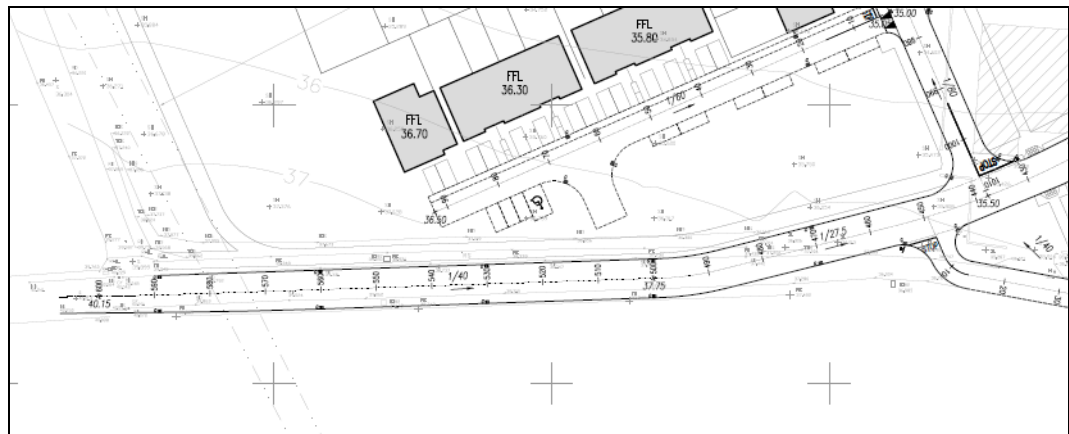
- It was noted that there is a significant level difference at present along the southern boundary of the site, on the approach to the M1 overbridge, as shown in figure 38. The site proposals indicate provision for a footway along this boundary, which is shown in

figure 39, however the design plans do not show details for earthworks or fencing at this location to address the level difference.

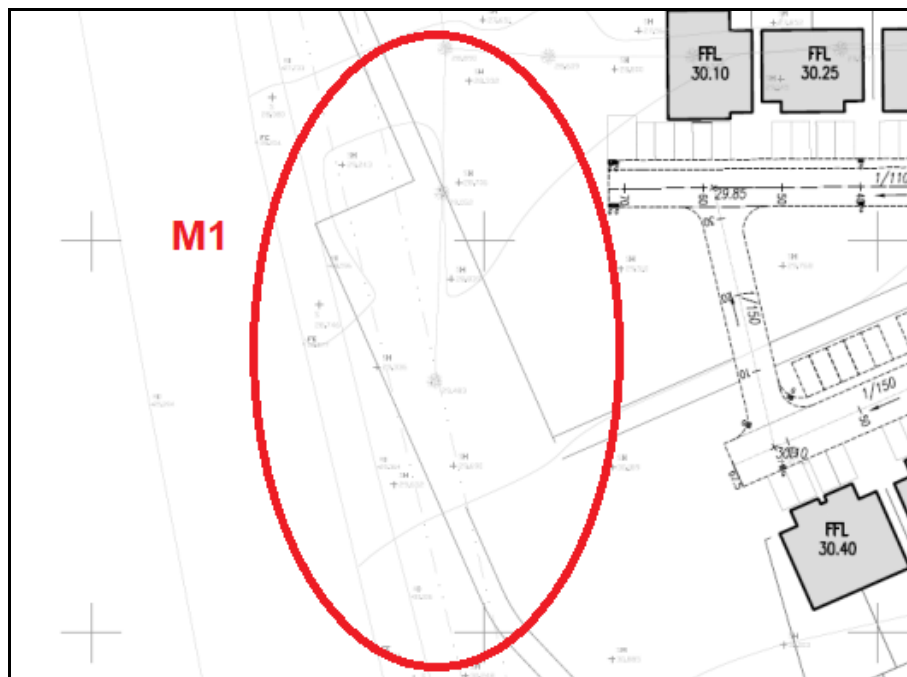
Figure 40

- The proposals for the area to the west of the site, shown in figure 40, are unclear from the plans supplied. This area is located immediately adjacent to the M1 motorway, where there are significant embankments, level differences and dense vegetation, as shown in figures 41 and 42. The proposals for this area should be clarified at detailed design stage to ensure there is no impact on the motorway operation, including the potential for lighting interference, with safe secure fencing to be provided to prevent child access onto the motorway.

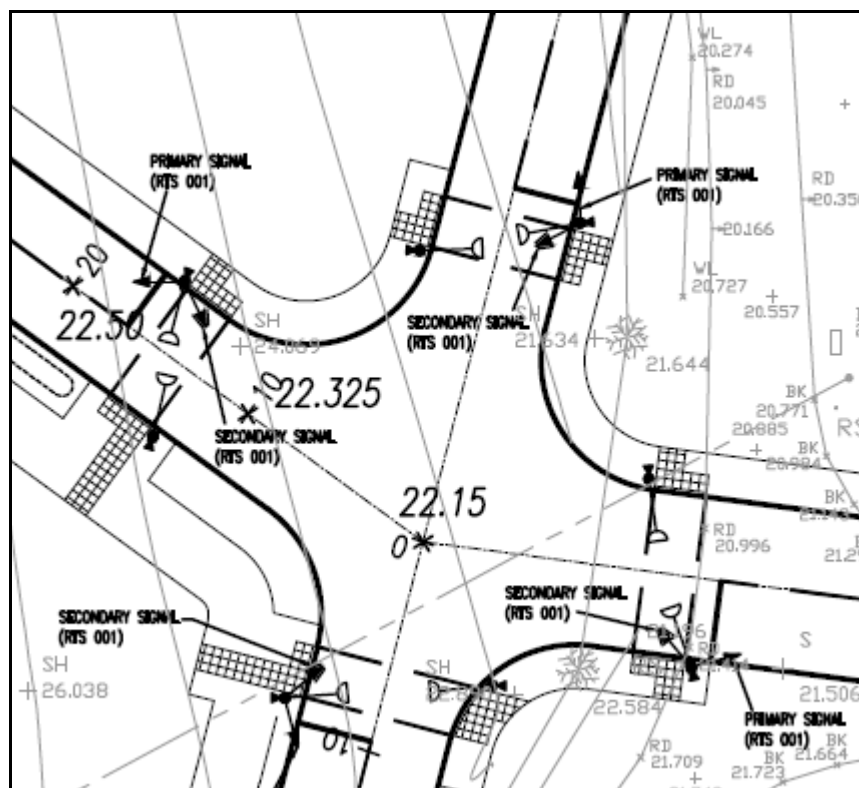
Figure 43

- Stoplines appear to be located too close to crossings at the signalised crossroads, as shown in figure 43, presenting an increased risk of vehicular over-run and potential for vehicular/pedestrian conflict.

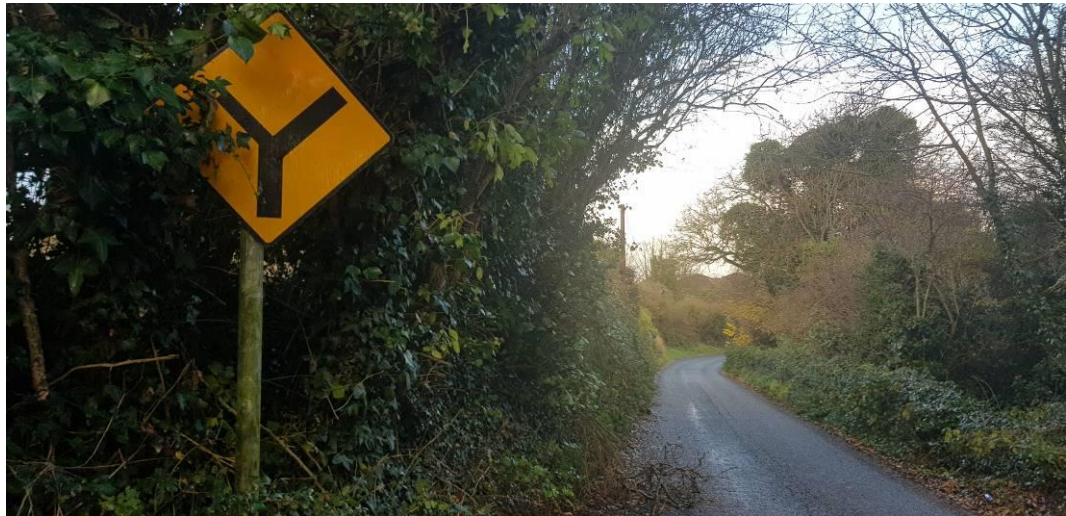
Figure 44

- A number of existing signs are likely to be displaced by the scheme proposals, e.g. figure 44, or do not relate to the proposed layout and will be made redundant and should be removed.

- The mounting height and location of existing signs is likely to present a hazard to VRUs if retained in their current location.
